Mercedes 722.6 Series: Keeping It Simple

The 722.6 has been around since 1996 in Mercedes-Benz vehicles and has been offered in Chryslers and Jeeps since 2001. Until recently there hasn't been a great deal of technical information available to the transmission repair industry; that is, unless you can read German. In this edition of *Fun With Transmissions*, we'll take a look at some problem areas and the very simple solutions on this series of transmissions.

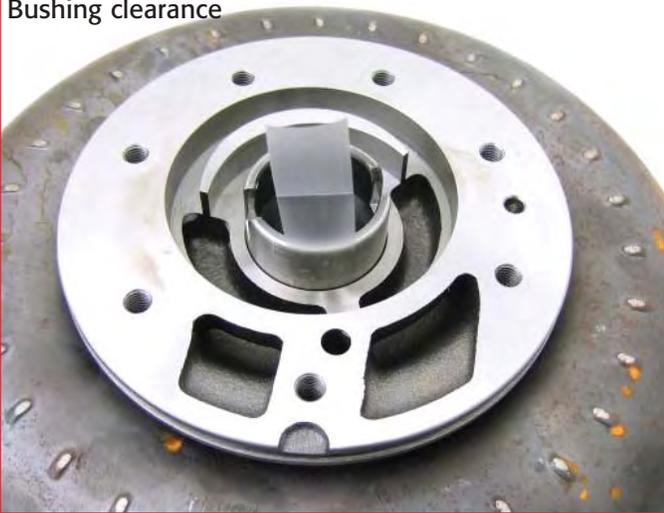
Figure 3

The pump body and bushing are much the same as in years past. Carefully inspect the pump bushing for wear. These bushings are machined to fit the torque converter at the factory. The factory keeps about a 0.002" to 0.005" maximum clearance on this bushing. This is easy to check: Apply a piece of cellophane tape to the converter hub (figure 3). Cellophane tape is usually 0.0015" to 0.002" thick. When you slide the pump onto the converter hub, there should be very little to zero movement at the bushing. If the pump still rocks a bit, try another piece of tape and the pump should barely fit.

Bushing clearance

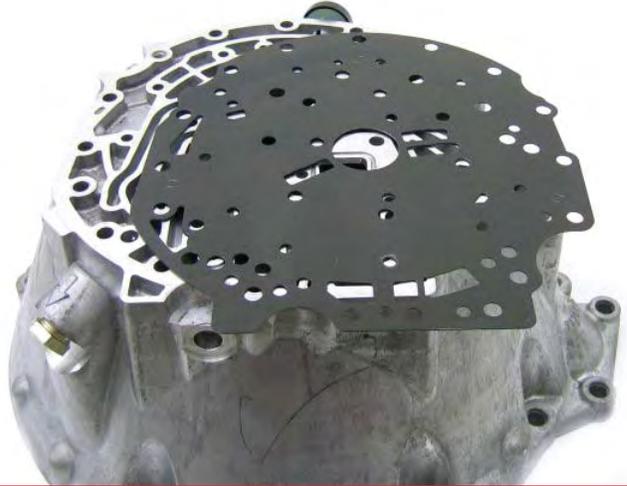
Figure 4

The pump separator plate is a latex-

coated plate (figure 4). The latex coating serves as the pump-to-case gasket and is available from the aftermarket. You should replace this plate during every rebuild.

Replace the teflon coated plate everytime

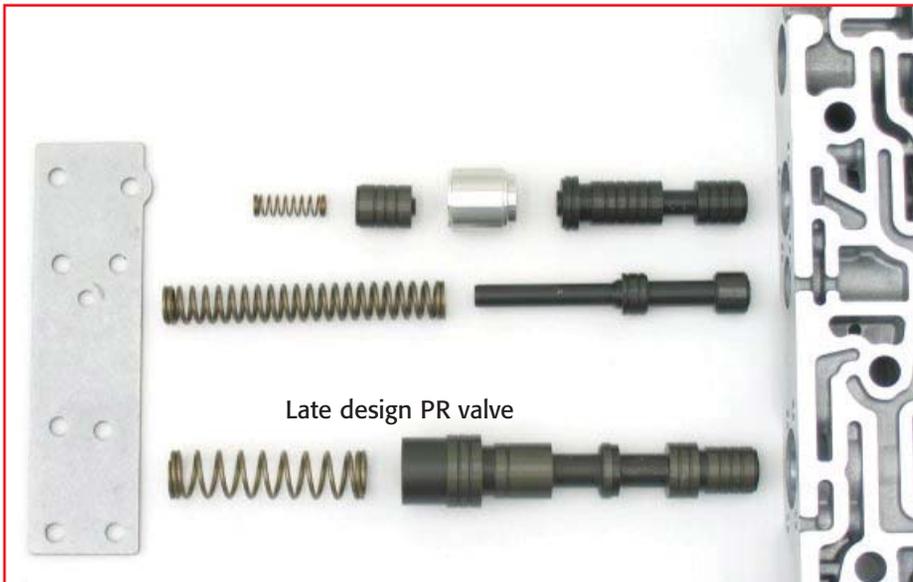
Figure 15

Earlier versions of the valve body have a slightly different pressure regulator (PR) valve design than the valve shown (figure 15).

Earlier versions of the valve body have a slightly different pressure regulator (PR) valve design than the valve shown (figure 15). The earlier design PR valve spring tended to break; the part number for the replacement spring is 140 993 58 01. Remember, these are Teflon-coated valves, so never use

abrasives on them. If the valves are really stuck, you may have to replace the valve body.

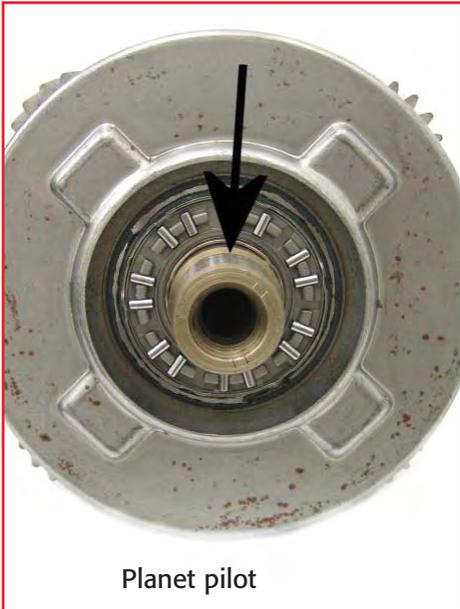
Figure 16

Early planet assemblies had terrible durability problems. Thrust bearings liked to blow up and take out the whole planetary gear set. This was such a problem that the earlier design planets are no longer sold. Even if you can find a core with a good used early planet

Planet pilot

Measure the snout of the planet (figure 16) to determine which planet you are working on. The early planet has a .908 in. pilot and the late model has a .866 in. pilot. To use the late planet with the early K2 drum, you'll have to use the aftermarket bushing or needle bearing and seal we discussed earlier.

setup, *don't use it!* You'll be headed for a planet failure if you go this route.

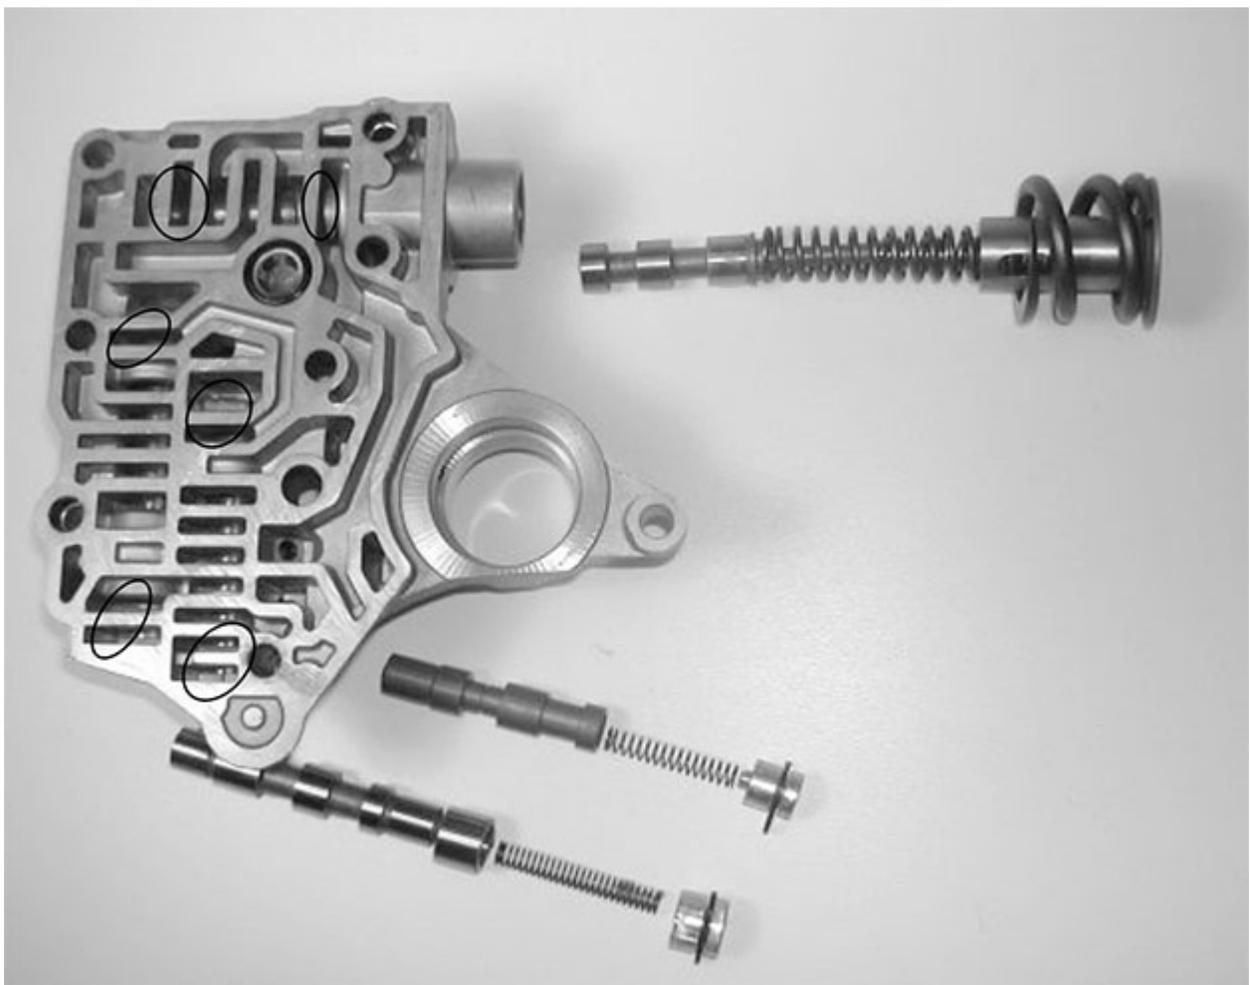
1. Main control body bore wear (critical points at circles).

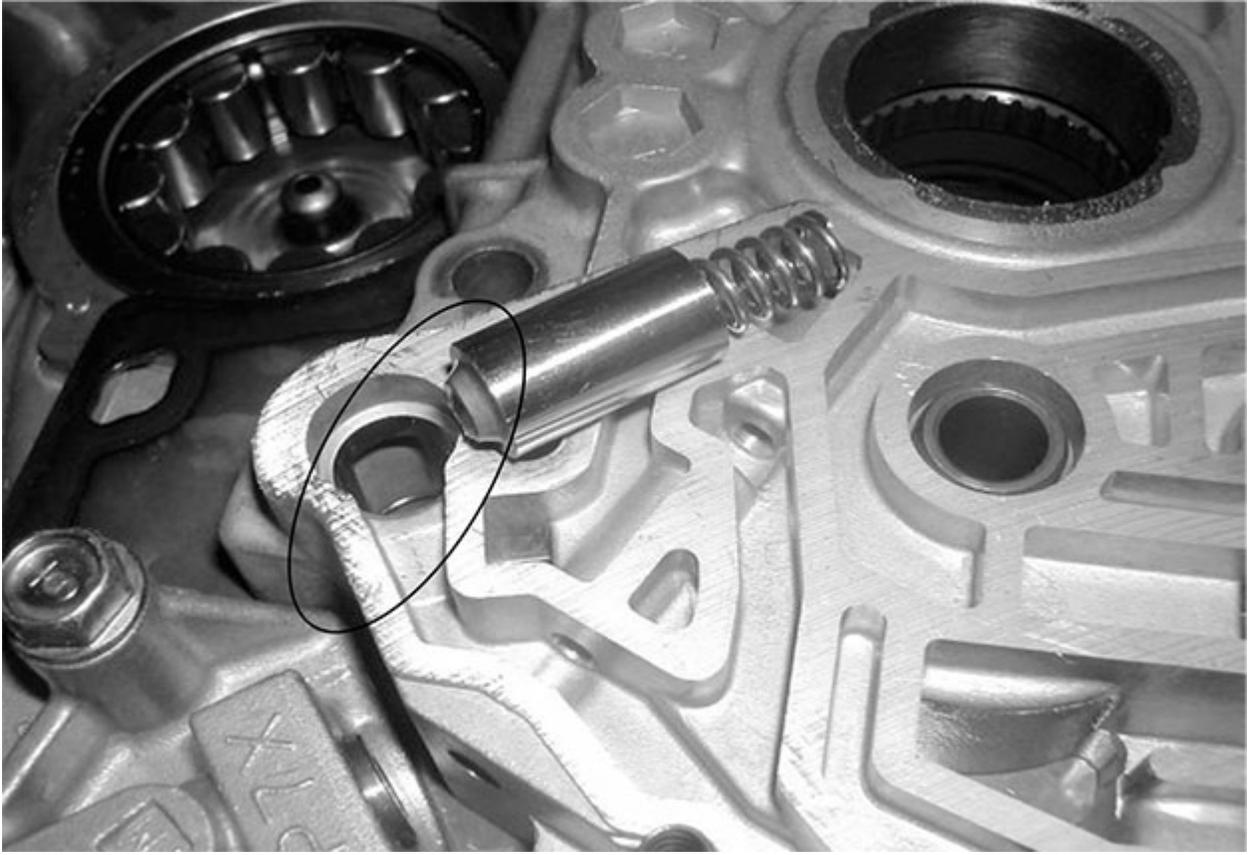
Control valve body worn at the converter relief bore. To isolate prior to removal, compare scanner data to the cooler flow. You should see the TCC command and amperage change in parallel to a cooler flow change on a SonnaFlow®.

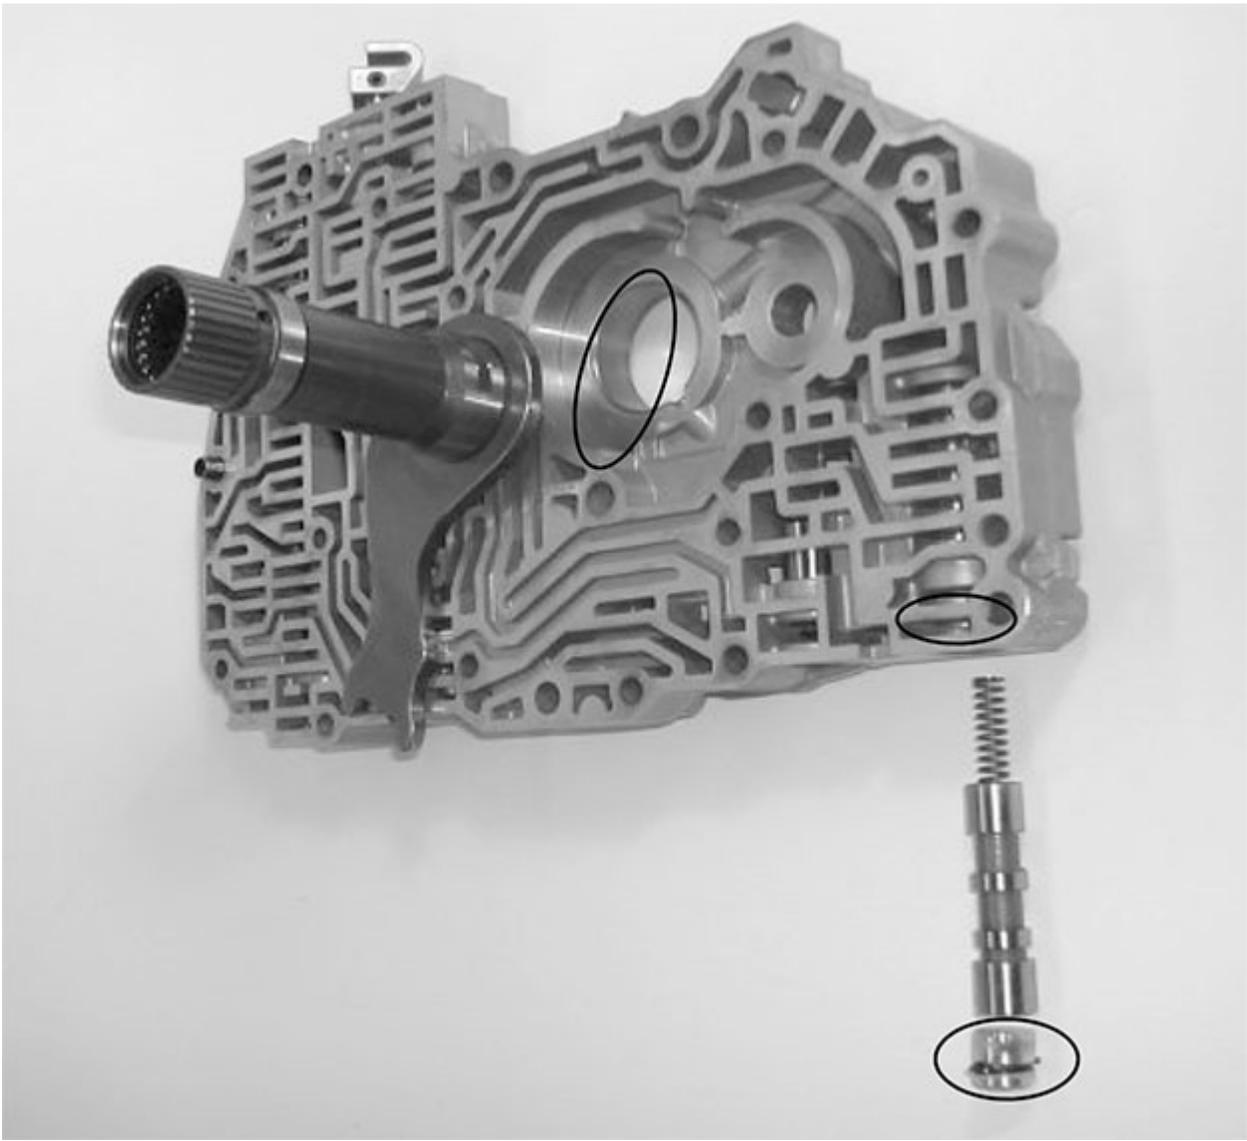
Loss of TCC or TCC slip: Created by end plug loose at the TCC control valve. A cross leak of converter charge oil into TCC control negatively affects TCC control. Inspect the stator for cross leakage at the finished area, where it passes through the casting.

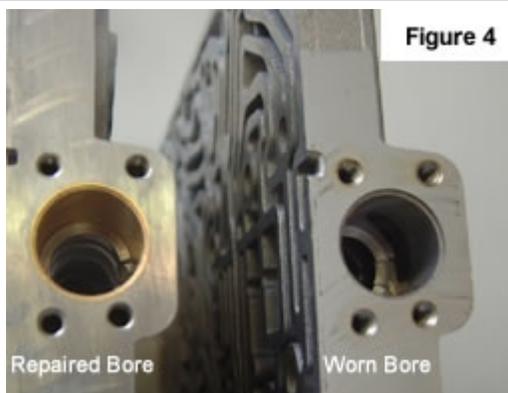
In 1998, many of the high mileage cars we repaired under Mercedes warranty had the same problem: 2-3 flare causing the vehicle to go into limp mode. After several inspections we discovered the link between the working pressure bore wear and the shift problems. We felt that the lack of hardness of the valve body material was the cause of this common failure. We designed a bushing to correct the leakage, using a harder material that would allow it to last longer when paired with a high speed valve. The valve is a long, one-piece design, and when it is leveraged on the larger end, it also loads into the bore on the smaller inboard end. Both of these wear conditions can be discovered by either a vacuum test (**Figure 3**) or a visual inspection. **Figure 4** shows a worn bore on the right and a repaired bore on the left.

Repaired Bore

Worn Bore

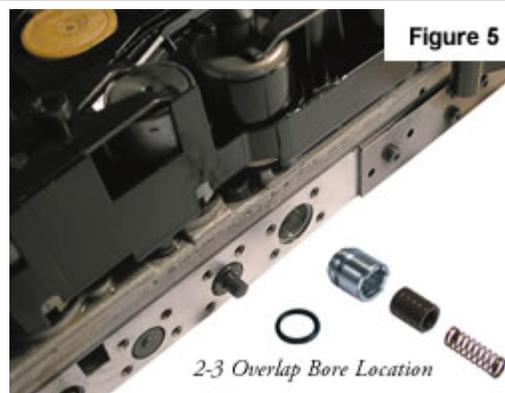
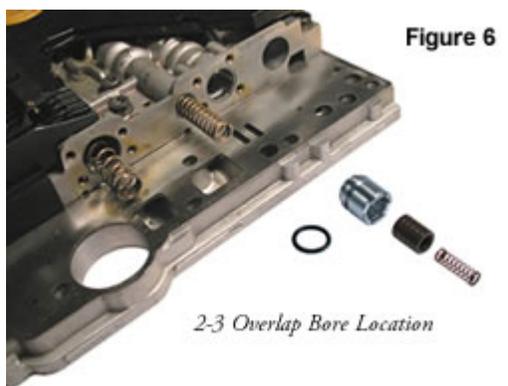
2-3 Overlap Bore Location

The 1-2 /4-5, the 2-3 and the 3-4 Overlap Sleeves are also in the pMod solenoid signal circuit (**Figures 5, 6 and 7**). It is common for them to wear on the I.D. and to leak at the O.D. as well. Wear at any of these sleeves reduces pressure at the working pressure valve. These sleeves can be vacuum tested prior to removal or cleaned and inspected for wear.
