Mercedes 722.6 Series: Keeping It Simple

The 722.6 has been around since 1996 in Mercedes-Benz vehicles and has been offered in Chryslers and Jeeps since 2001. Until recently there hasn't been a great deal of technical information available to the transmission repair industry; that is, unless you can read German. In this edition of *Fun With Transmissions*, we'll take a look at some problem areas and the very simple solutions on this series of transmissions.

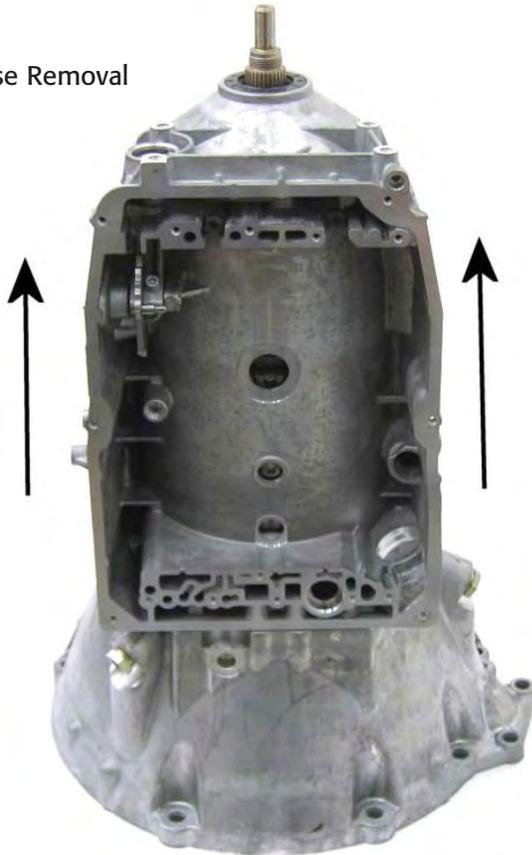
Figure 1

Once you've removed the valve body and bellhousing bolts, the case just lifts off the entire gear train assembly (figures 1 and 2). This makes for easy gear train disassembly and reassembly.

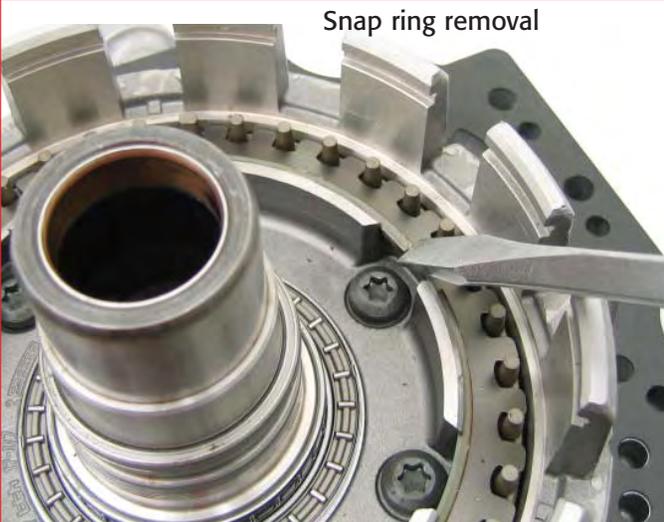
Figure 5

The B1 clutch assembly has the only molded piston in the unit, and, like the pump plate, should be replaced on every rebuild. The piston is also available from aftermarket parts suppliers. To remove this piston, strike the snap ring sharply with a screwdriver and hammer to bounce the L-shaped snap ring out of the groove, much as you would the snap ring on the E4OD overdrive piston assembly (figure 5).

Snap ring removal

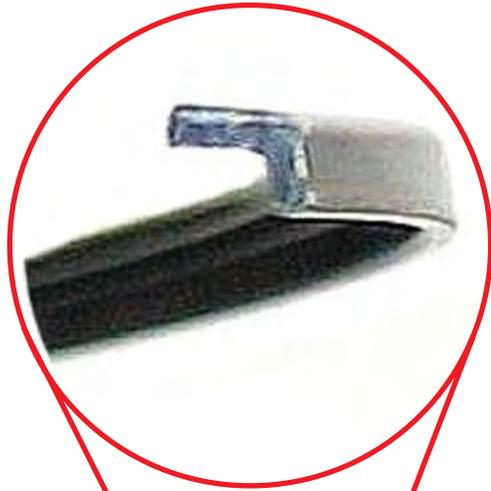
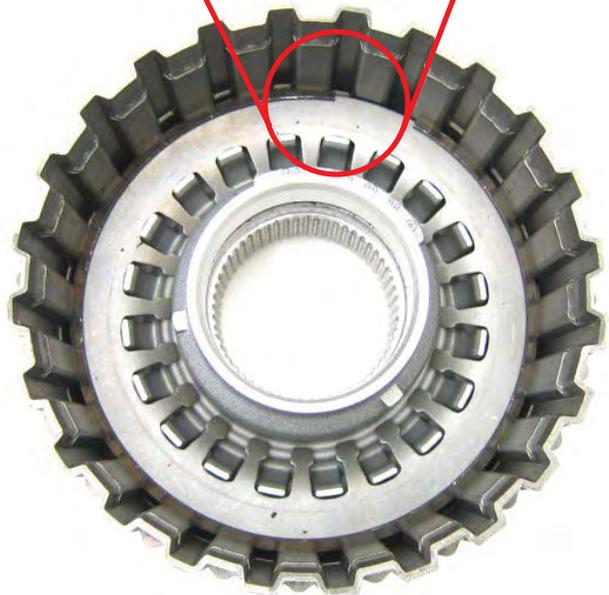
Figure 6

For the most part the clutch drums are pretty basic. All the clutch drums use Bellville return springs. These springs can be a bit tricky to work with; you have to compress them evenly to remove the L-shaped retaining snap rings (figure 6). You'll need to do a bit

L-Shaped snap ring

of creative thinking to fabricate a tool from leftover parts available around the shop to perform the job you'd normally use a factory tool to do. For example, you can use the direct clutch sprag race from an AX4S to compress the Bellville spring in the B2 clutch drum. For the K3 clutch drum, a large tapered roller bearing race works nicely. Figure 7 shows a bearing race and support from a Subaru final drive being used.

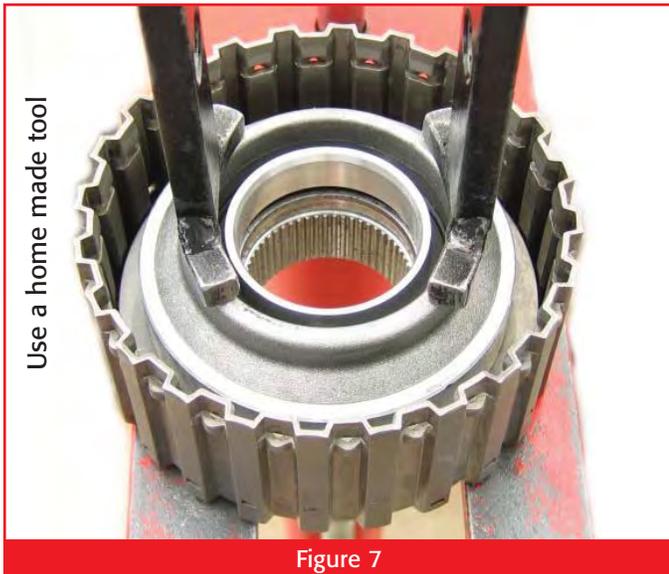
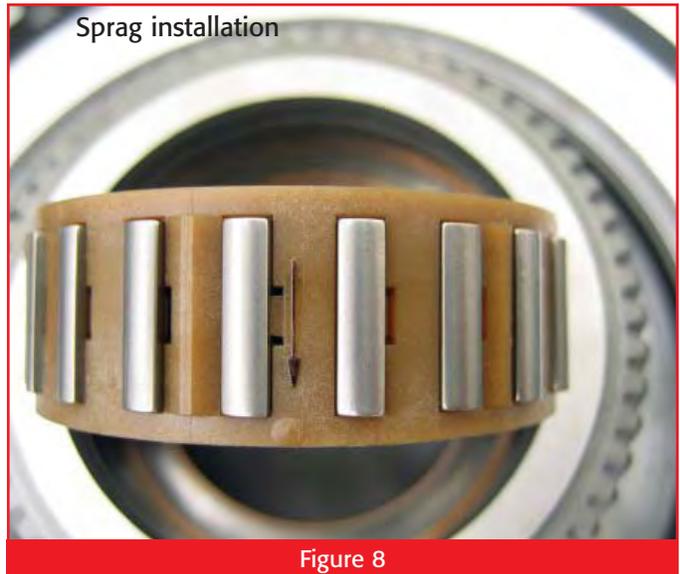
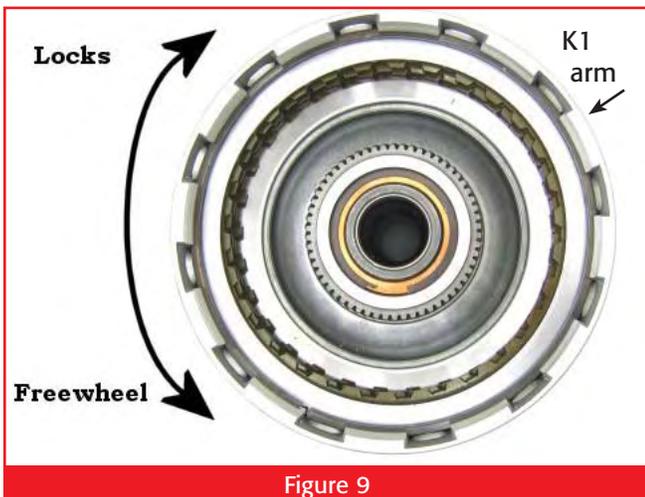
durability. The part number for the updated sprag is A 140 270 02 31. Both early and late sprags have an arrow on the cage (figure 8) which faces down into the drum when installed properly. When installed onto the pump, the K1 drum should freewheel counterclockwise and lock clockwise (figure 9). The 20 element sprag assembly can and should be used in the earlier model transmissions with out any modifications.

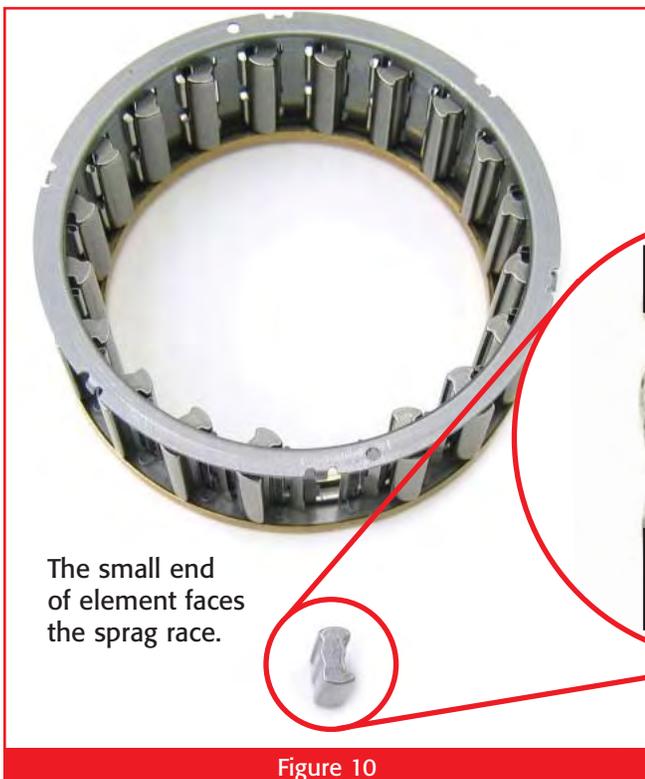
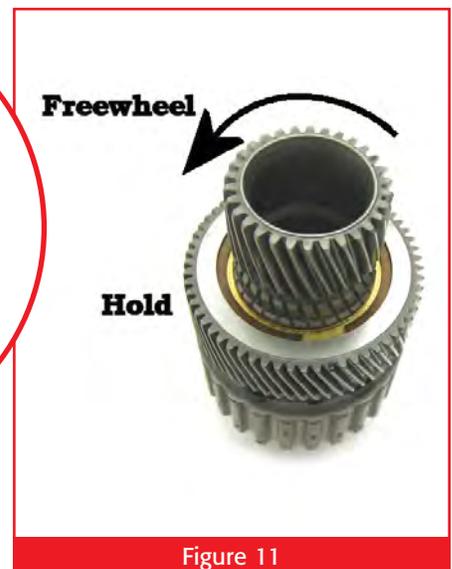
The rear sprag (F2) has had some durability issues, and can cause a 2-3 flare when isn't holding properly. This sprag has also been updated from 14 to 20 elements. The part number for the 20-element sprag is A 220 270 01 31. This assembly will also fit earlier applications and can be used without any modifications.

CAUTION!: Be very careful handling this sprag! The elements fall out of the cage very easily. Refer to figure 10 for proper element installation. When the sprag is installed properly the sun gear will freewheel counterclockwise and lock clockwise (figure 11).

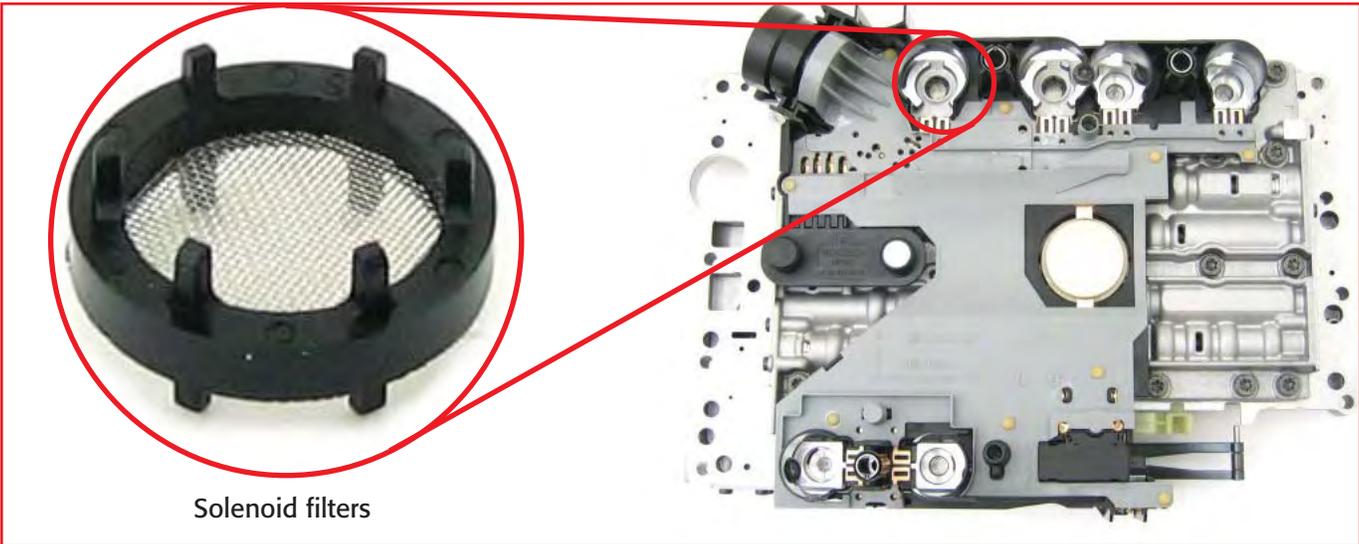
Figure 12

The valve body is yet another example of simplicity. There are 3 shift solenoids, 2 pressure control solenoids and 1 TCC solenoid. There are a couple small parts to watch for as you take the valve body apart. Look for the screens under the pressure control solenoids (figure 12).

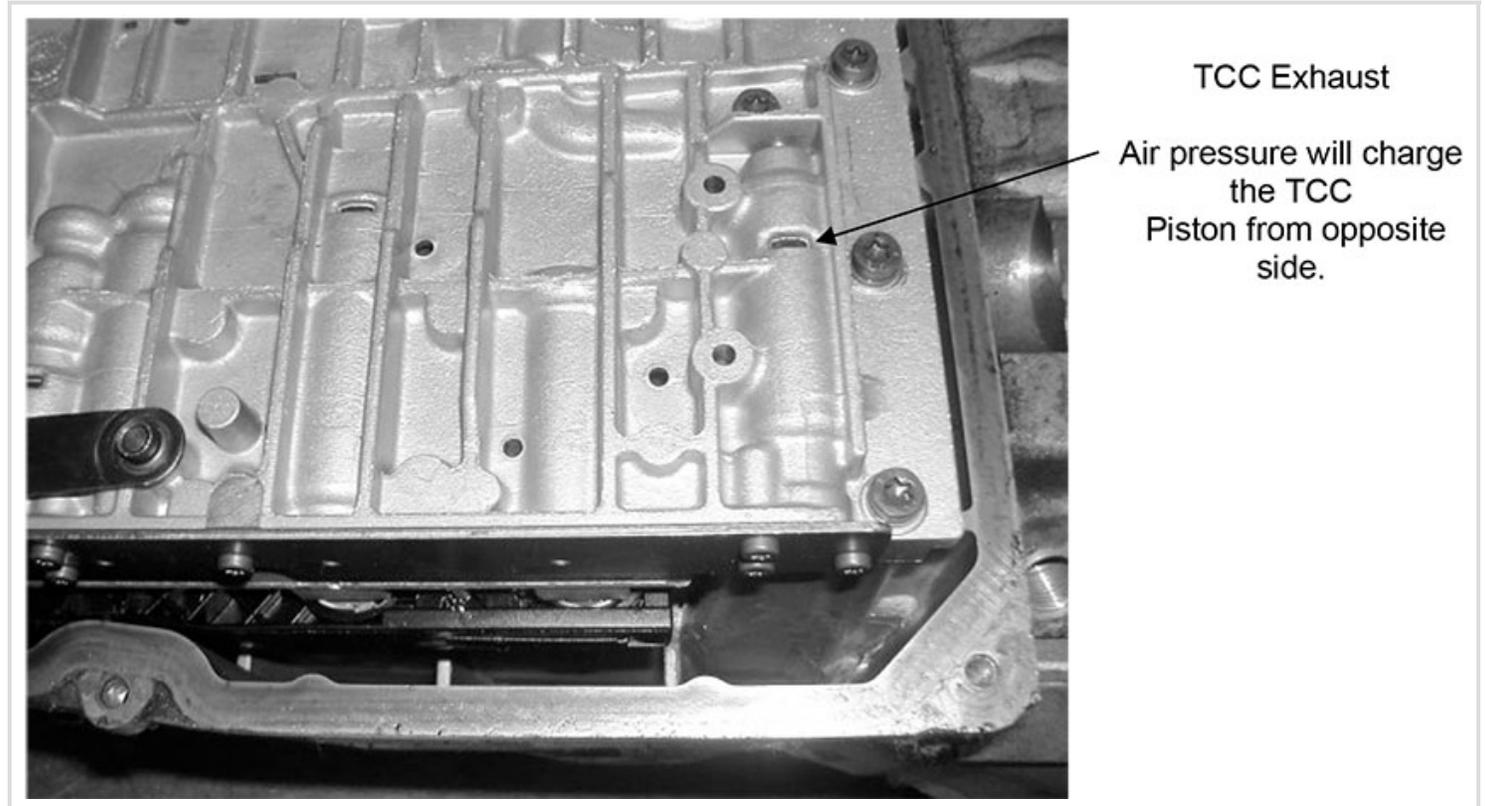
1. The TCC apply circuit can be air tested, (30-60 psi.) with the unit in the vehicle and the valve body in place. Charge the exhaust hole. The air supplied will push remaining fluid into the converter TCC piston. Minimal leakage should come out cooler lines or other valve body locations.

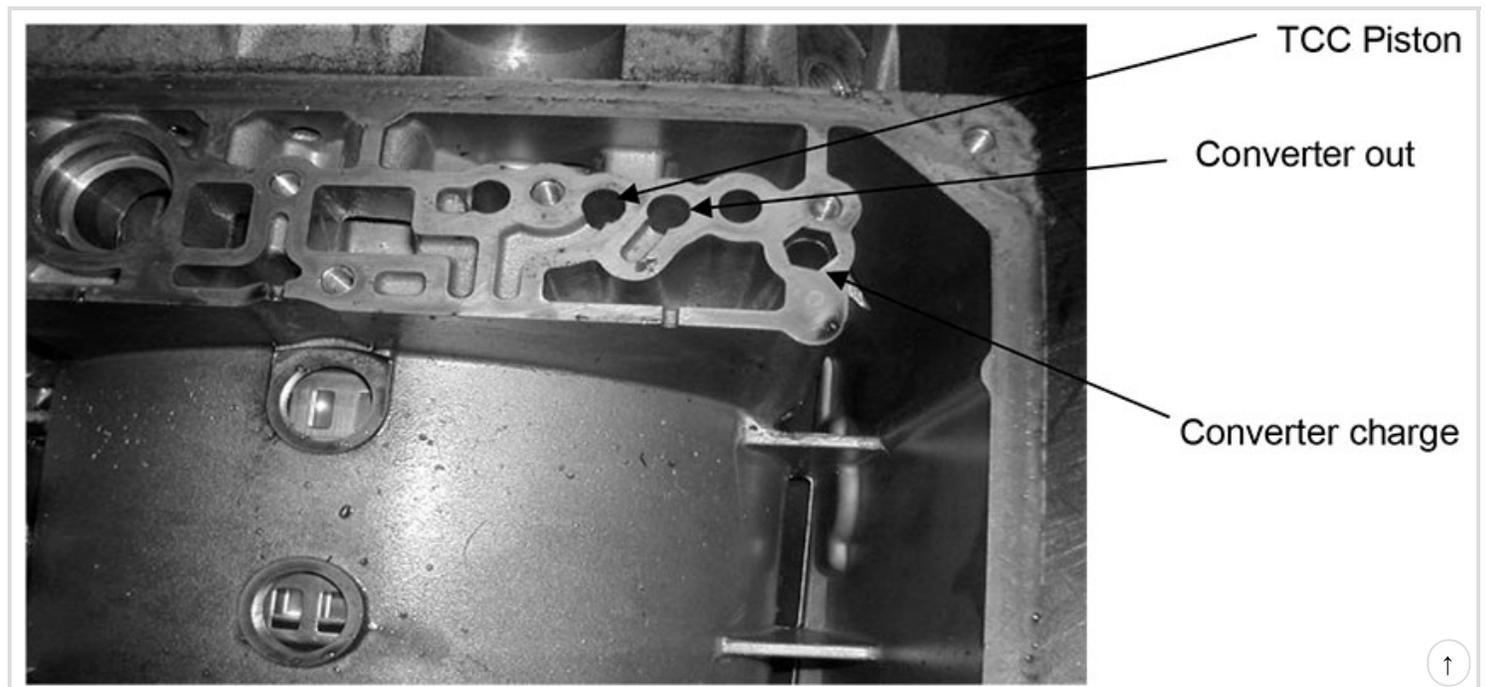
If the valve body is removed, the three converter circuits can be isolated. Any leakage from converter charge or converter out, is from cross leak at the pump or within the converter.

Note: Teflon®-type of sealing rings require fluid to lift. If air testing with a dry circuit, they will cross leak. Turbine shaft sealing rings should be the OE overlap design. Valve body must be flat and the pump stator or converter cross leaks should be eliminated. Internal transmission bushings insure the turbine shaft runs true, a requirement for the rings to seal.

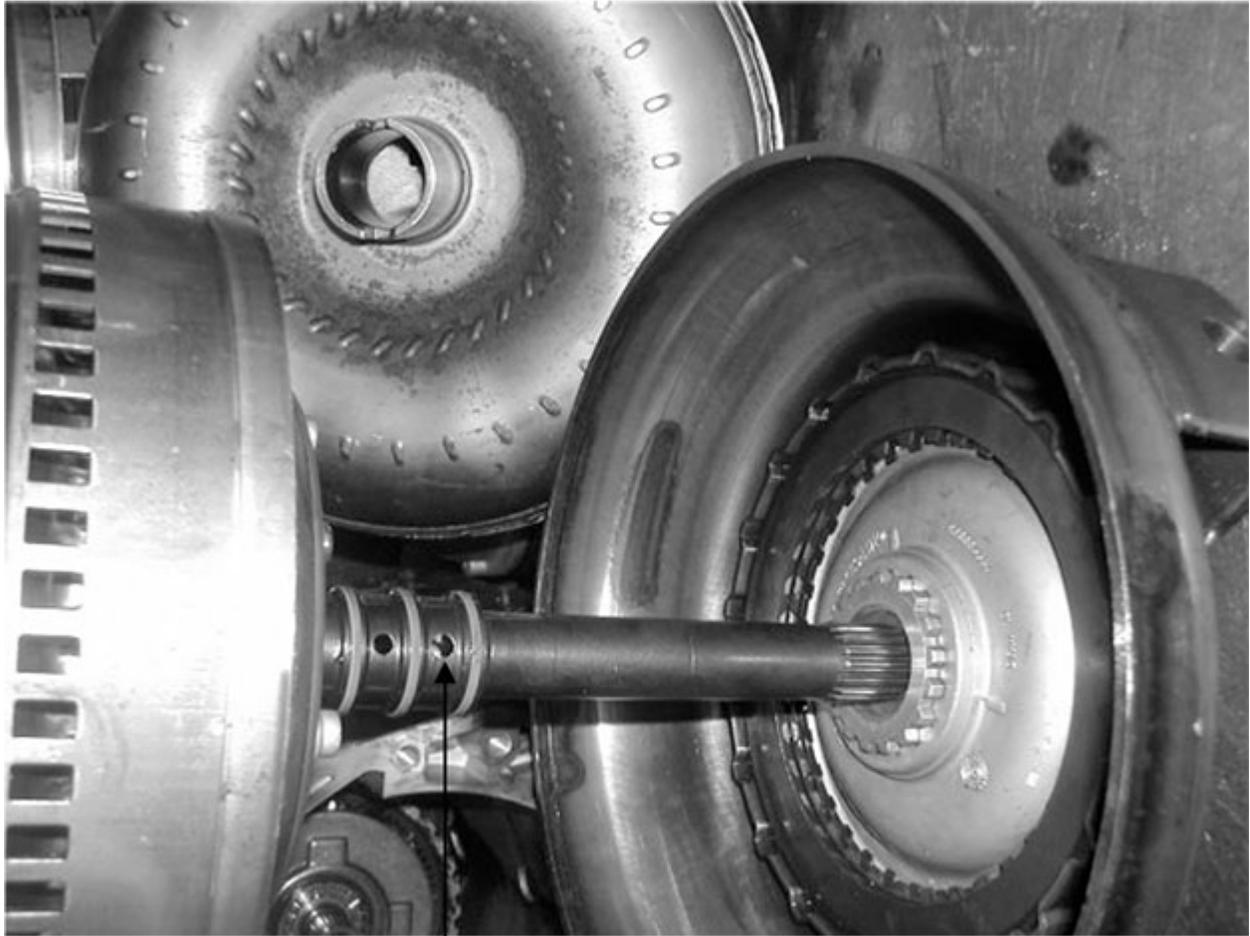
TCC Piston Apply

- Leakage of converter pressure into the TCC piston area
- Low converter apply pressure, due to valve bore wear
- Defective TCC solenoid

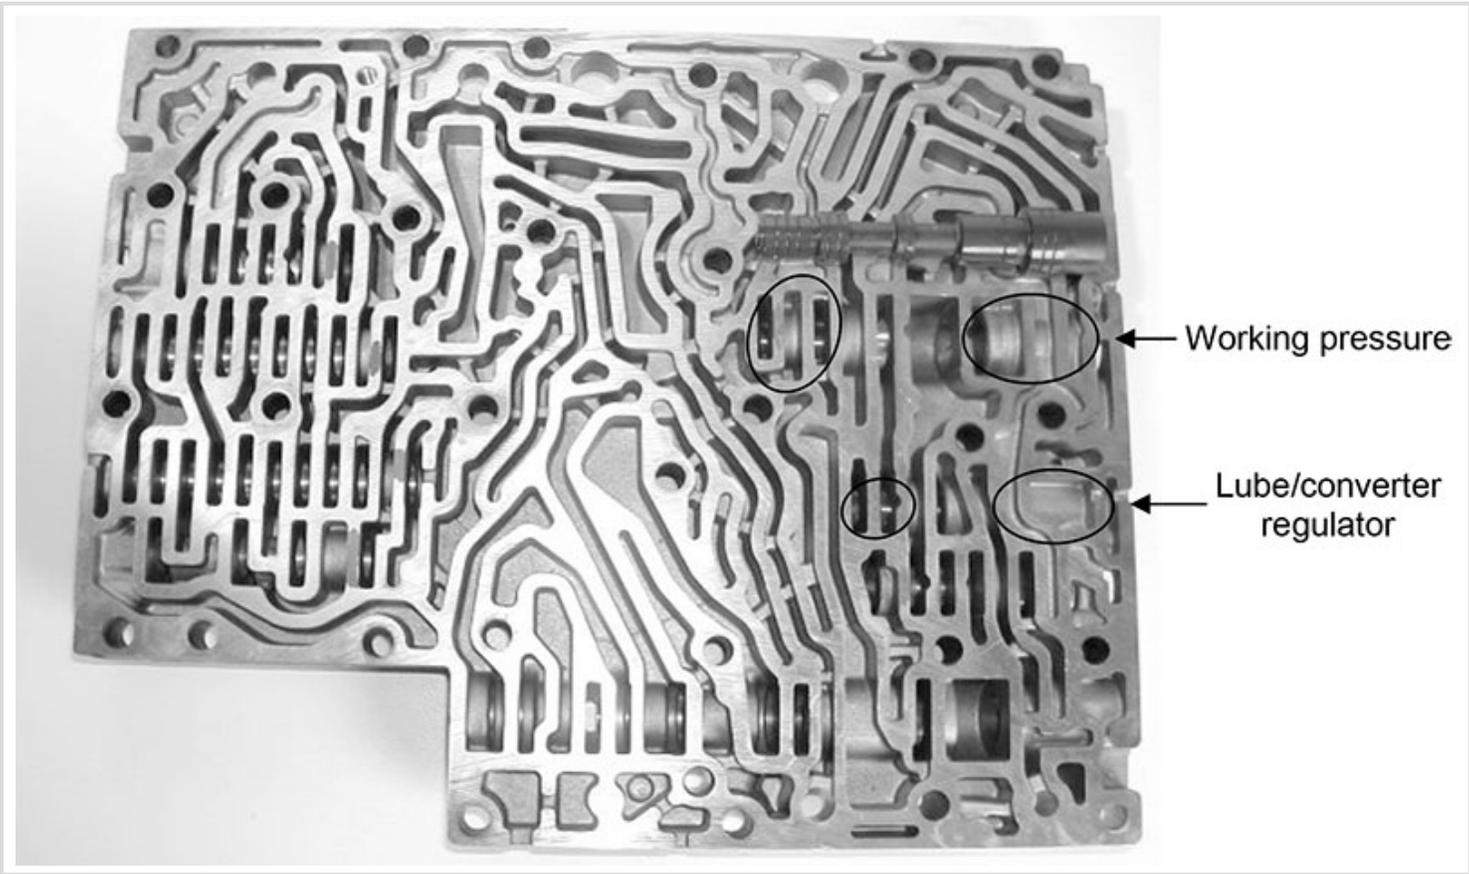
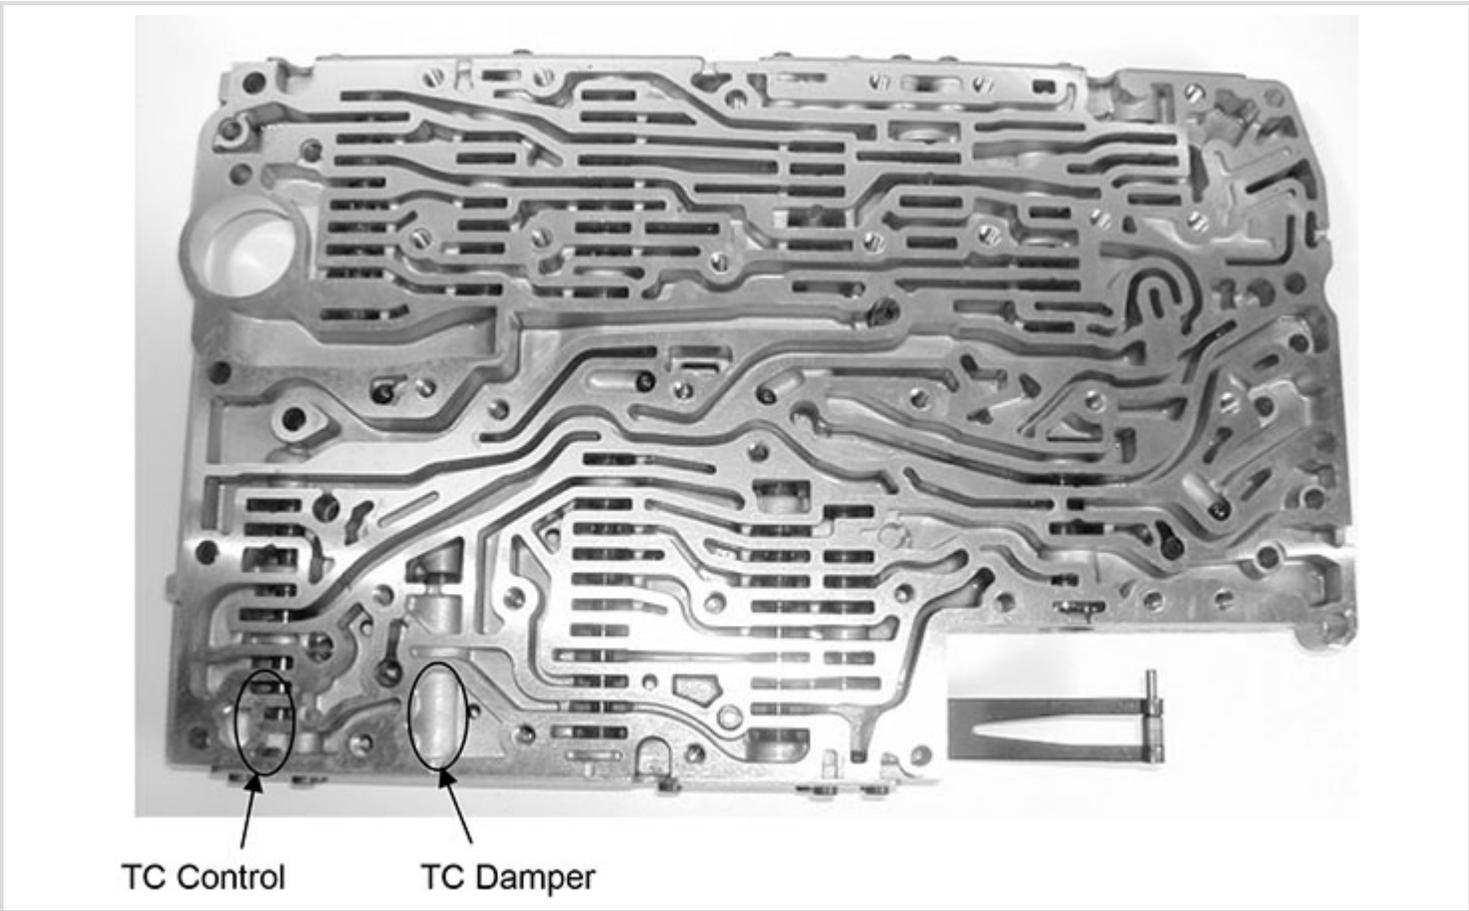
2. Low converter apply pressure extends from the main/working pressure regulator bore and the Lube/converter limit valve. Wear at either area affects TCC and converter charge psi. Critical wear points within circles (shown in photos below.) The TC control valve must stroke for full apply. Bore wear at either location reduces the TCC solenoid's ability to stroke the valves.

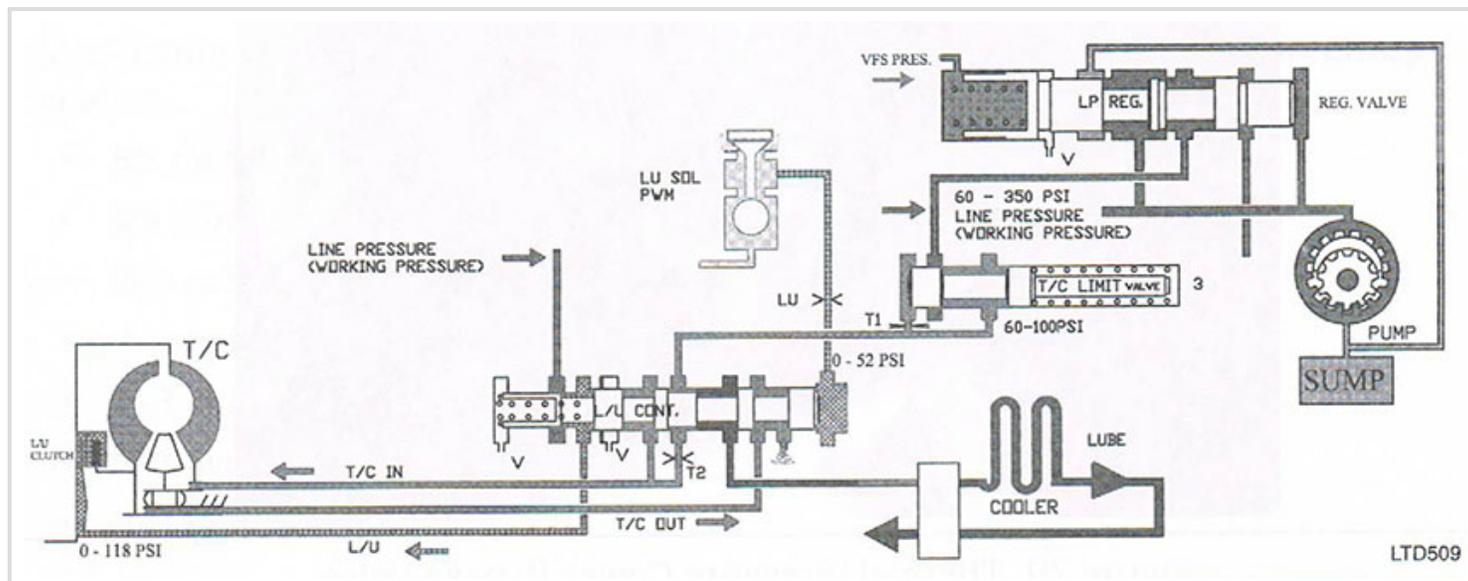
3. The normally closed, Y3/ 6y6, TCC solenoid strokes the torque converter lockup valve. If the Y3 solenoid leaks into the control valve circuit, the valve may rest in a partial apply position.

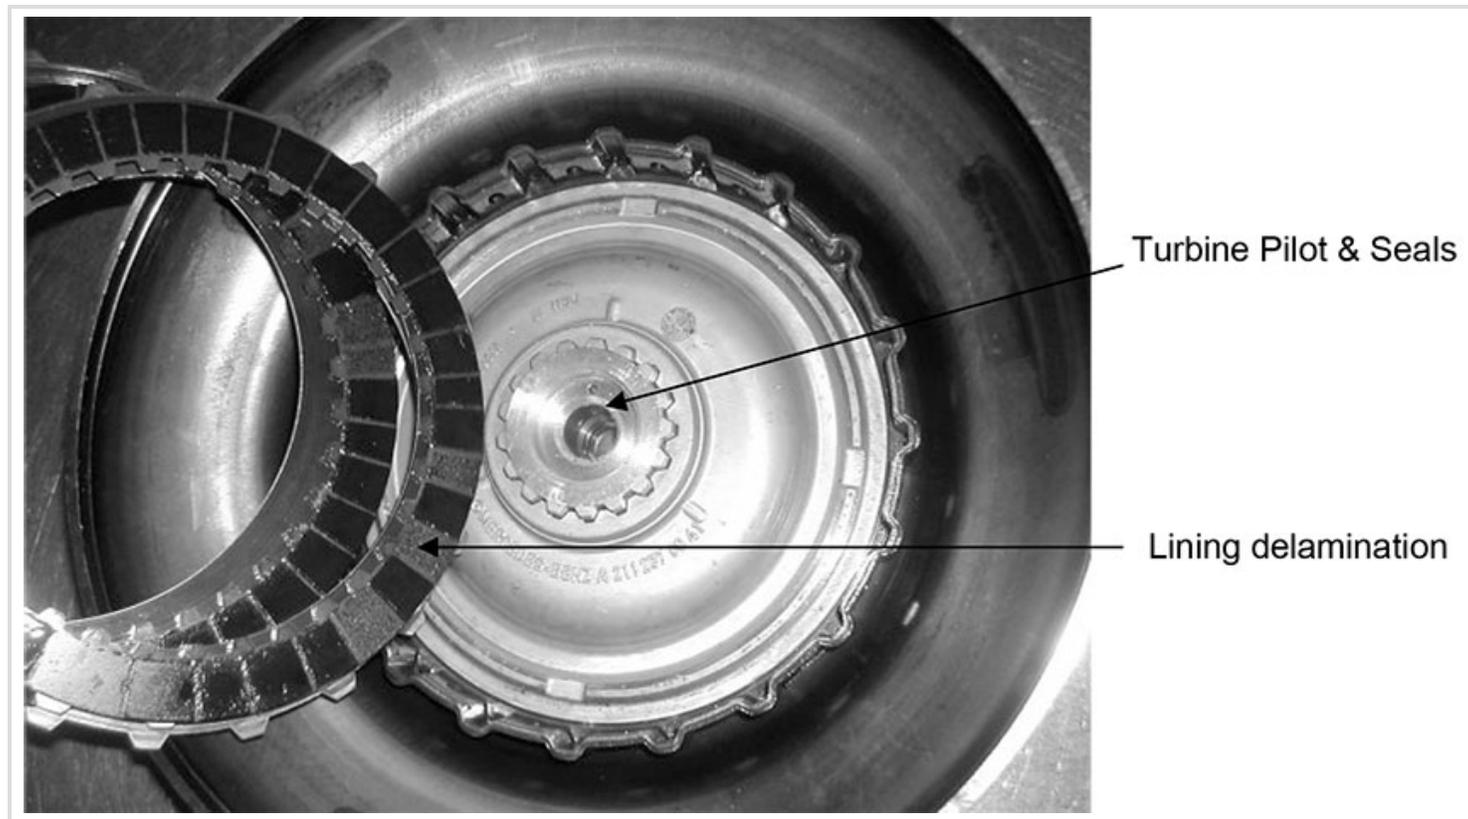
4. Test for water or antifreeze in ATF. In some applications, one drop is sufficient to degrade clutch linings.

Mercedes kit # 000-989-009 and 000-989-0014

An alternative is to use a hot plate and check for a sizzle noise as the water burns off.

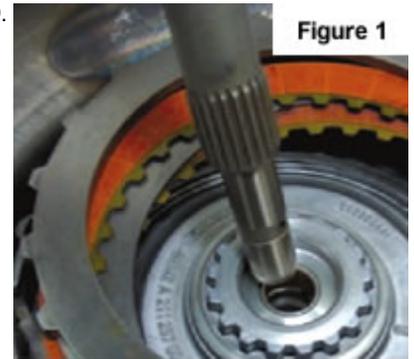
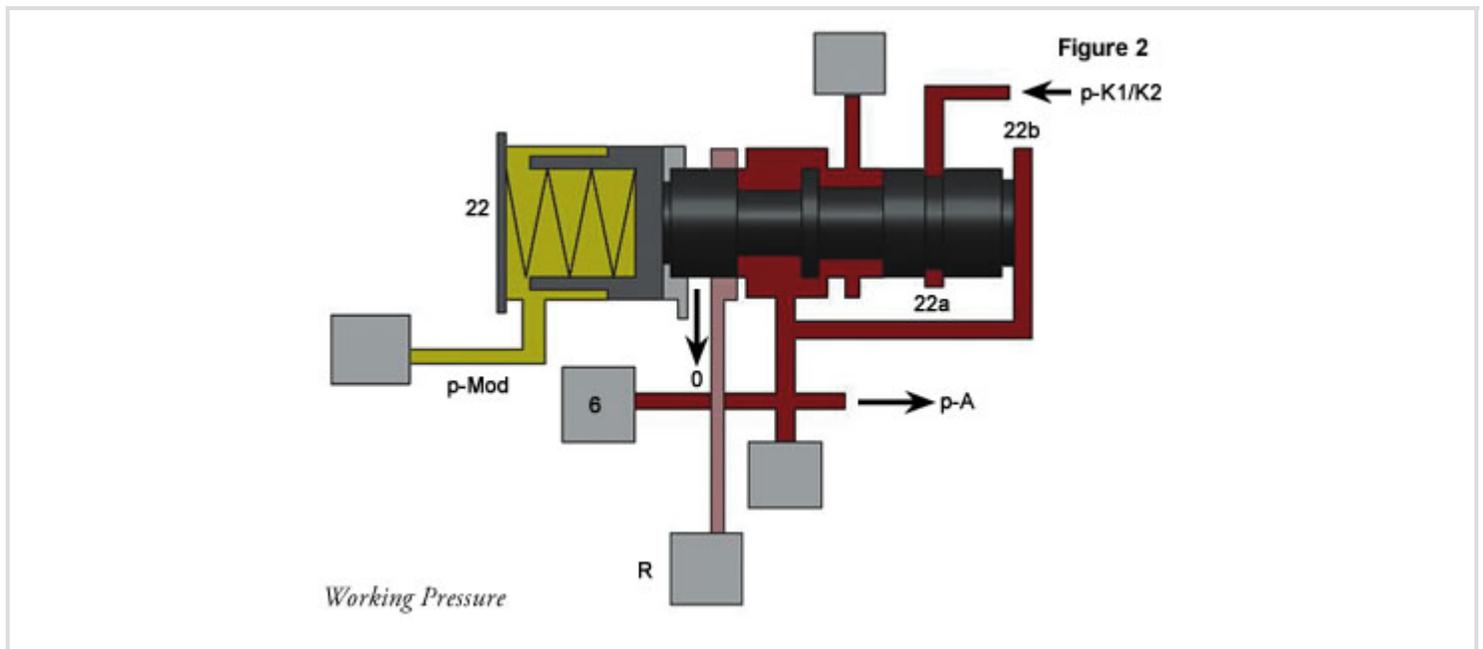
Torque Converter Clutch

This article will focus primarily on drivability issues related to the electro-hydraulic control unit or valve body. This gearbox was one of the first 5 speeds with a new concept in load sensitive Working Pressure and Overlap Clutch Control. The converter was also unique because of its multi-disc torque converter clutch (**Figure 1**).

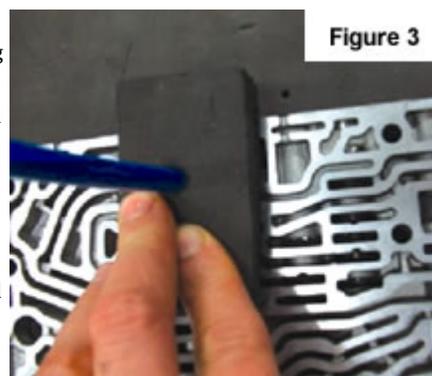
Vacuum test for working pressure valve

All these advances require precise hydraulic control, which leads us to the problems discussed here. One of the drivability complaints involves engine RPM flare on 2-3/4-5 upshift or a neutral flare on a 5-4/3-2 downshift. During upshift or downshift under load, line pressure (referred to as working pressure in the 722.6) must be responsive. The outer bore of the working pressure regulator valve wears and allows the pMod solenoid signal oil to leak past the boost end of the valve (**Figure 2**). As the casting wears, working pressure does not increase with engine load and the flare or loss of gear occurs.

In 1998, many of the high mileage cars we repaired under Mercedes warranty had the same problem: 2-3 flare causing the vehicle to go into limp mode. After several inspections we discovered the link between the working pressure bore wear and the shift problems. We felt that the lack of hardness of the valve body material was the cause of this common failure. We designed a bushing to correct the leakage, using a harder material that would allow it to last longer when paired with a high speed valve. The valve is a long, one-piece design, and when it is leveraged on the larger end, it also loads into the bore on the smaller inboard end. Both of these wear conditions can be discovered by either a vacuum test (**Figure 3**) or a visual inspection. **Figure 4** shows a worn bore on the right and a repaired bore on the left.
